## PA/VSI Or RFA FILE REVIEW CHECKLIST

Facility Name: Henkel Surface Tech. (Parker Div.)

Reference: PRC Environmental Management, Inc.  
VSI Project No. 209-R05032M140  
Parker+Amchem  
EPA I.D. No. MID057676124

<u>Section</u>	<u>Page</u>
EXECUTIVE SUMMARY .....	ES-1
1.0 INTRODUCTION .....	1
2.0 FACILITY DESCRIPTION .....	4
2.1 FACILITY LOCATION .....	4
2.2 FACILITY OPERATIONS .....	4
2.3 WASTE GENERATING PROCESSES .....	6
2.4 HISTORY OF DOCUMENTED RELEASES .....	11
2.5 REGULATORY HISTORY .....	12
2.6 ENVIRONMENTAL SETTING .....	13
2.6.1 Climate .....	14
2.6.2 Flood Plain and Surface Water .....	14
2.6.3 Geology and Soils .....	14
2.6.4 Ground Water .....	15
2.7 RECEPTORS .....	16
3.0 SOLID WASTE MANAGEMENT UNITS .....	18
4.0 AREAS OF CONCERN .....	26
5.0 CONCLUSIONS AND RECOMMENDATIONS .....	27
REFERENCES .....	32

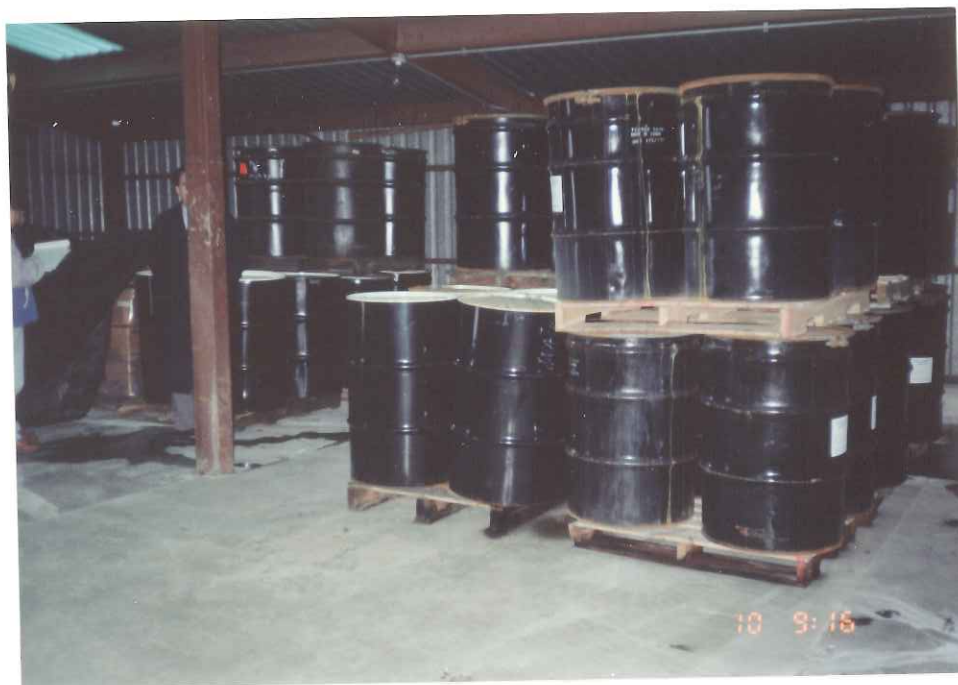
Photograph No. 1

The Hazardous Waste Storage Shed is part of a large shed located in the northeast corner of the facility's property. The unit is for less than 90-day storage of hazardous waste in containers. This unit may store 55-gallon containers of paint-related wastes and 55- and 30-gallon lab pack containers, which contain small quantities of excess laboratory chemicals. Nonhazardous wastes that are stored in this area include filter press sludge, heat transfer oil, waste oil, lubricants, and oil emulsion. The waste management area measures 37 feet by 32 feet, and is part of a large shed measuring 37 feet by 80 feet. The waste management area is separated from the rest of the shed by a wall, that has a door, and by diking. The maximum capacity of this SWMU area is 195 drums. The unit is completely enclosed by galvanized metal walls and roof. The floor is diked and made of concrete (see Photographs No. 1 and 2). There are no floor drains in this area.

Location: SWMU 1

**Recommendations:** PRC recommends that Parker-Amchem label all drums accumulated in this SWMU. The facility should delineate areas within the SWMU for storage

of hazardous and nonhazardous waste. PRC also recommends that the space around the doors be sealed such that rainwater cannot enter the storage shed. Installation of monitoring wells outside of the SWMU could be used to assess past releases to ground water.

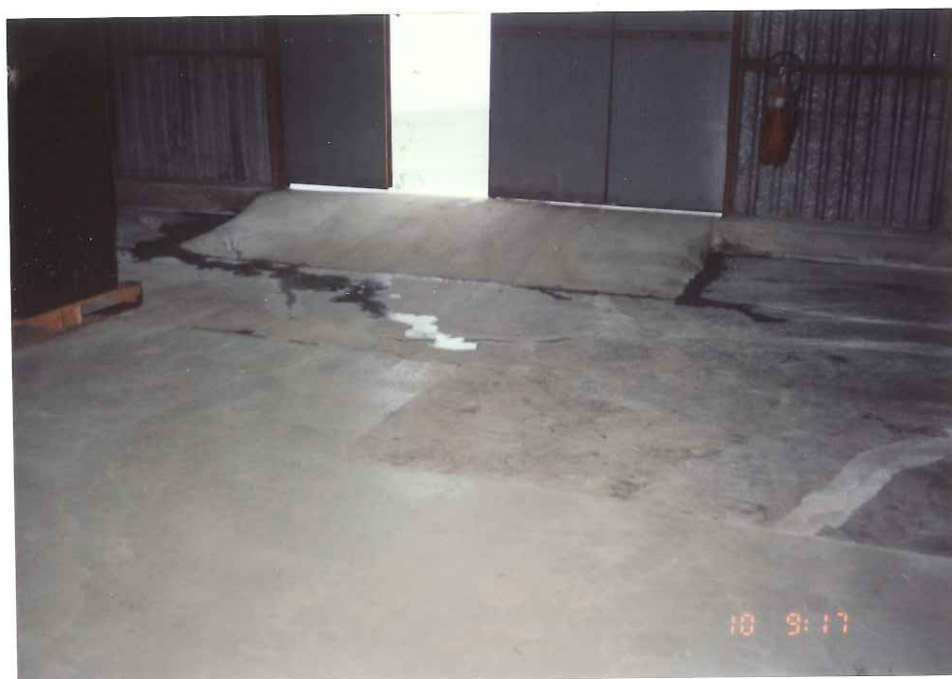
Photograph No. 2

Location: SWMU 1

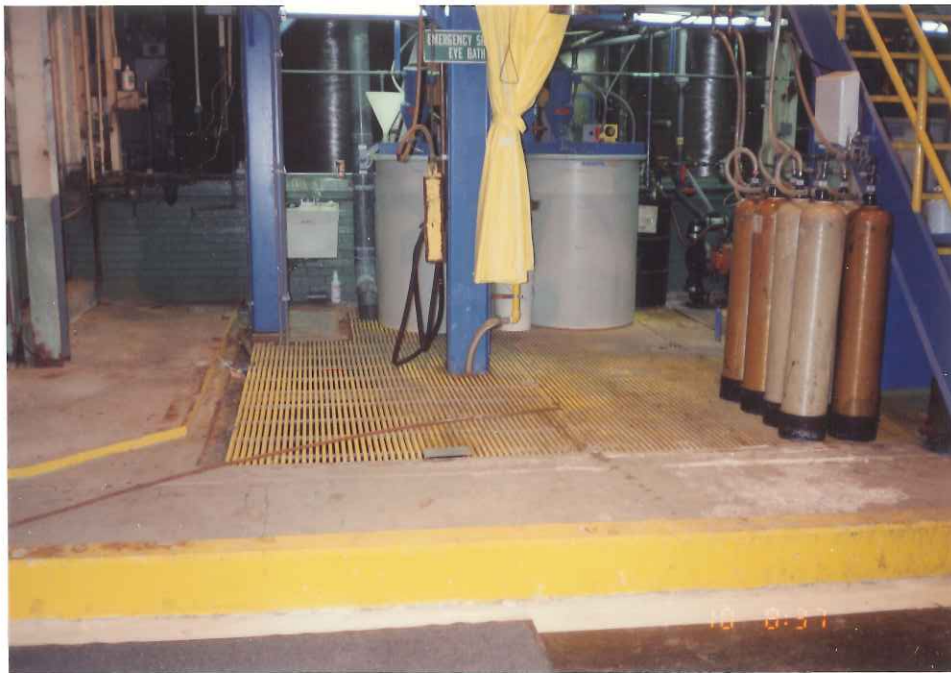
Photograph No. 3

The unit contained wastewater in various stages of treatment during the VSI. The discharge rate for the unit is approximately 19,000 gallons per day. PRC did not observe any cracks in the unit's floor. Wastewater was contained in pipes or the treatment tanks. The drum used accumulate for filter press sludge was closed. No evidence of release was noted.

Location: SWMU 2

PRC recommends no further action for this SWMU.

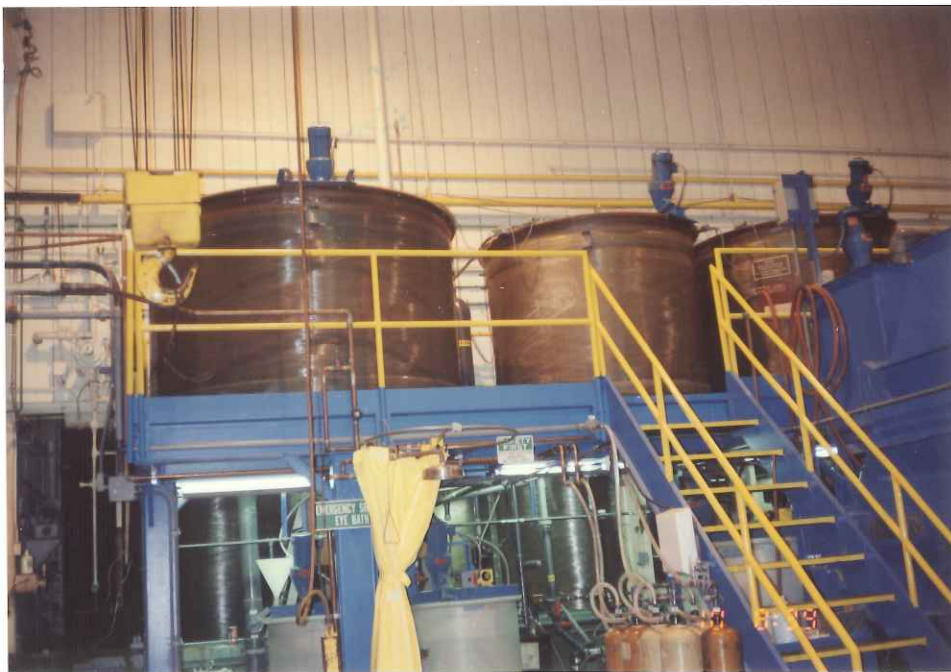
Photograph No. 4

Location: SWMU 2

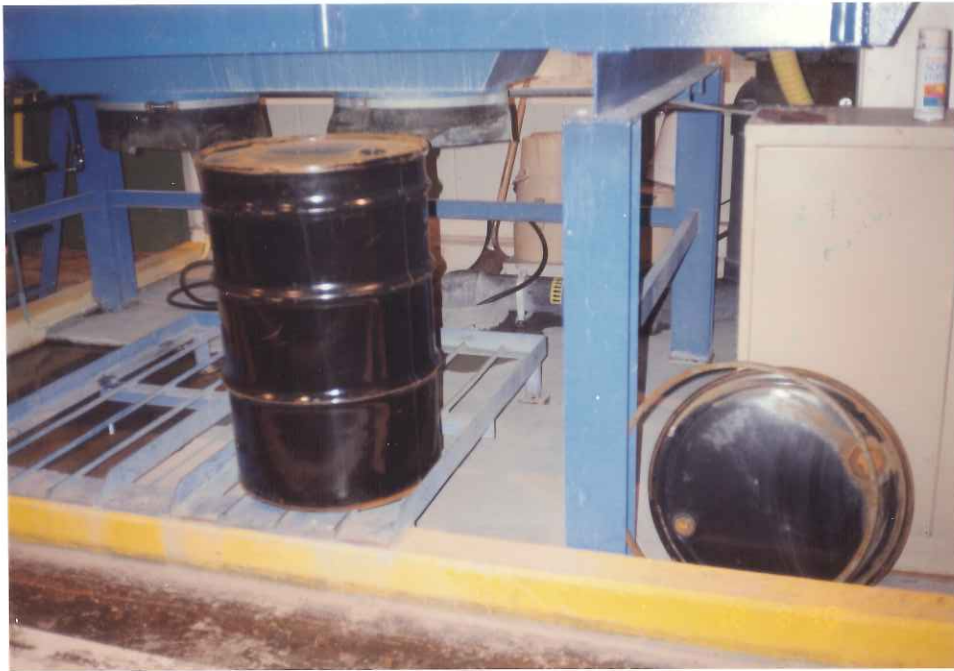
Photograph No. 5

Location: SWMU 2

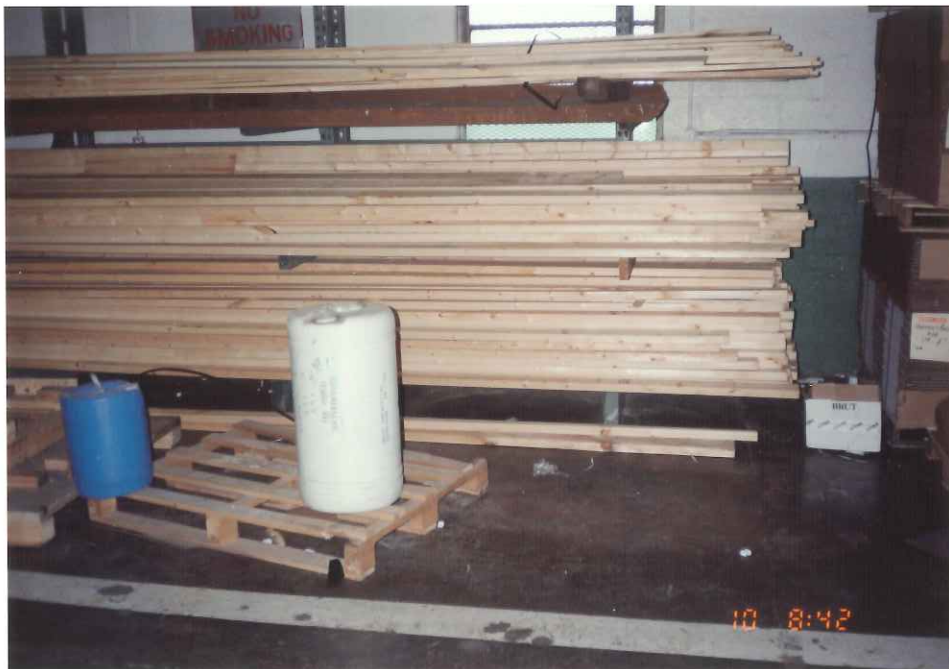
Photograph No. 6

The Indoor Hazardous Waste Storage Pad is located indoors just north of the shipping and receiving area. The unit was used to store drums of hazardous and nonhazardous wastes generated at the facility. The unit measured approximately 10 feet by 32 feet. The unit is made of concrete block walls and a concrete floor. The area was designated by floor markings (see Photograph No. 6). PRC did not observe any floor drains in the area.

Observations: At the time of the VSI, the unit contained planks of wood stored on brackets. No evidence of release was noted. No drums or waste were present.

Description: Closed indoor hazardous waste storage pad now used for storing wood; paint stripe of the floor indicates boundary.

Location: SWMU 3

PRC recommends that the facility obtain written documentation of RCRA-closure approval.

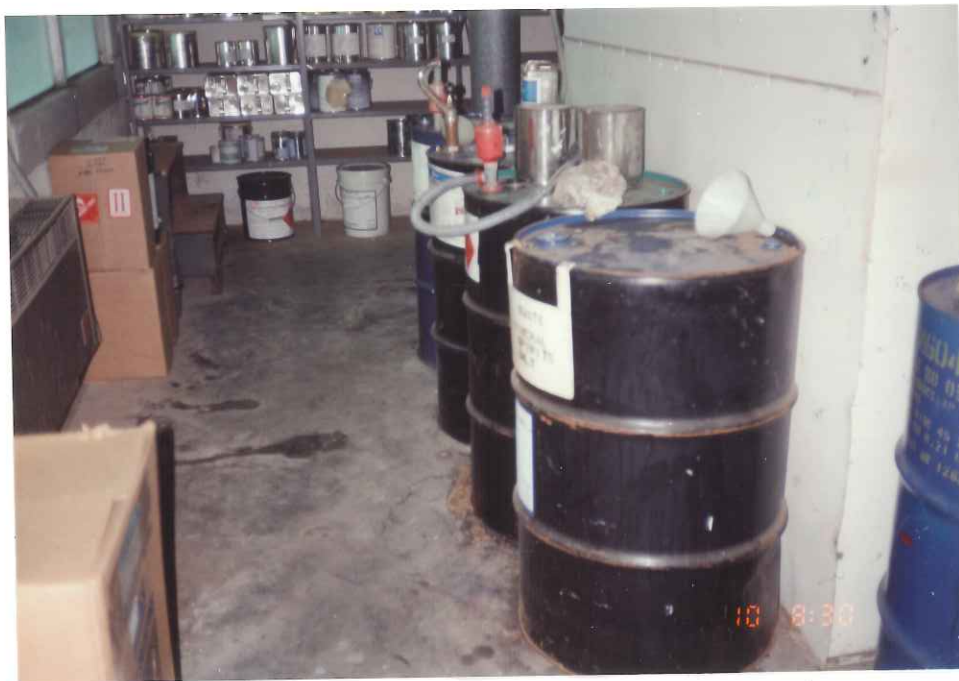
Photograph No. 7

Wash water generated during decontamination associated with RCRA-closure of the Hazardous Waste Storage Shed (SWMU 1) was temporarily being stored in 55-gallon drums on a concrete floor area adjacent to the Indoor Hazardous Waste Storage Pad (SWMU 3) at the time of the VSI. About 385 gallons of wash water was being held indoors at the time of VSI (see Photo No. 7). The wash water was treated in the WWTS (SWMU 2) subsequent to the VSI.

The unit contained one, 55-gallon steel drum each for the accumulation of paint waste and paint solvent (mineral spirits). PRC did not observe any floor cracks. Open drums of waste were present. The area was cluttered with boxes, and waste drum labels were not always clear. The waste drums were not segregated from product drums, which also were not clearly labeled. Splashes of paint were observed on the floor and walls. PRC also noted a strong solvent odor in the area.

Location: SWMU 4

General housekeeping in this unit should be improved. The facility should segregate supplies from wastes and nonhazardous wastes from hazardous wastes. The facility should ensure that all drums are clearly labeled and tightly closed.

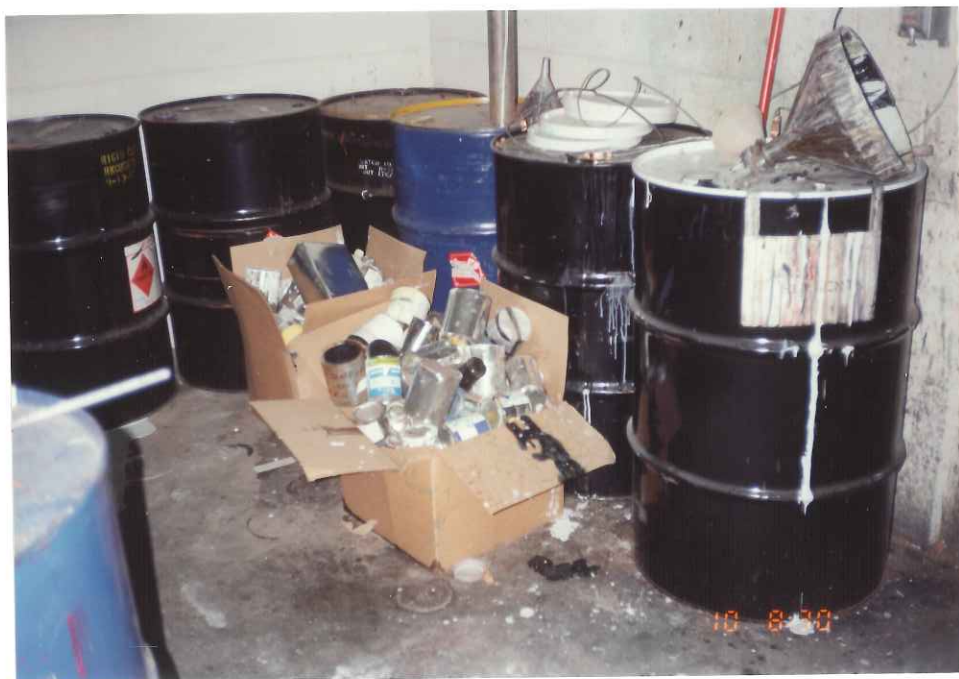
Photograph No. 8

Location: SWMU 4

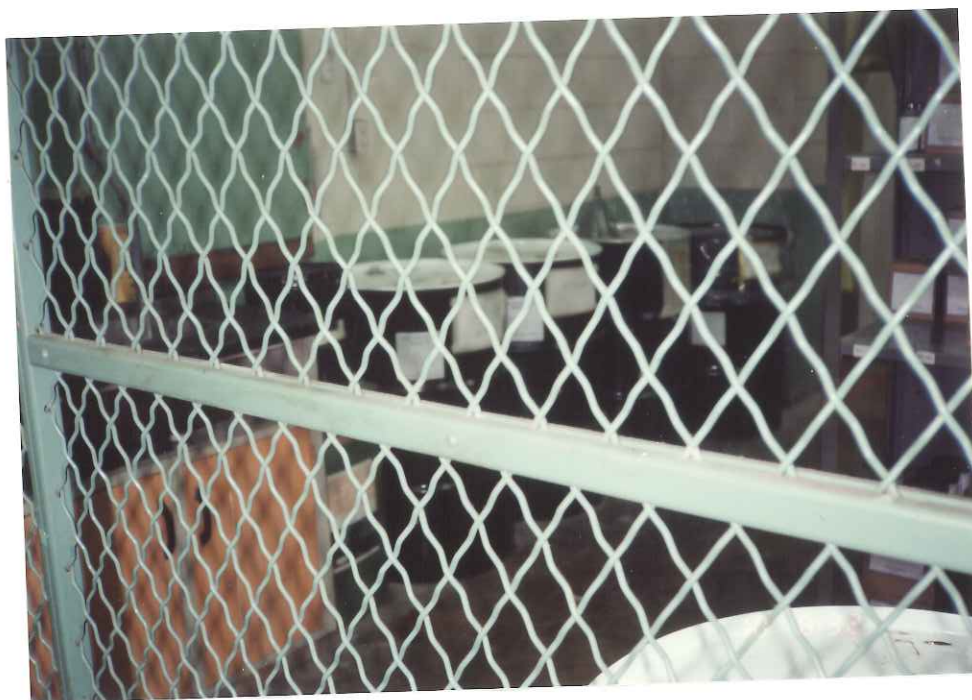
Photograph No. 9

The Nonhazardous Waste Storage Area is located in the chemical storage area inside the facility. The area stores laboratory chemicals, glassware, and related apparatus. A portion of the chemical storage area is used to accumulate nonhazardous waste oil, lubricants, heat transfer oil, and oil emulsion. The waste management area of the stockroom measures approximately 3 feet by 10 feet and has the capacity for four 55-gallon drums. The room is made of concrete block walls and a concrete floor. PRC did not note any sealing material on the floor, any cracks, or any floor drains (see Photograph No. 9). The entire chemical storage area is fenced in and has a locked gate.

Observations: The unit contained one, 55-gallon drum of each of the following during the VSI: heat transfer oil, oil emulsion, waste oil, and lubricant. No evidence of release was noted.

Location: SWMU 5

Recommendations: PRC recommends no further action for this SWMU.

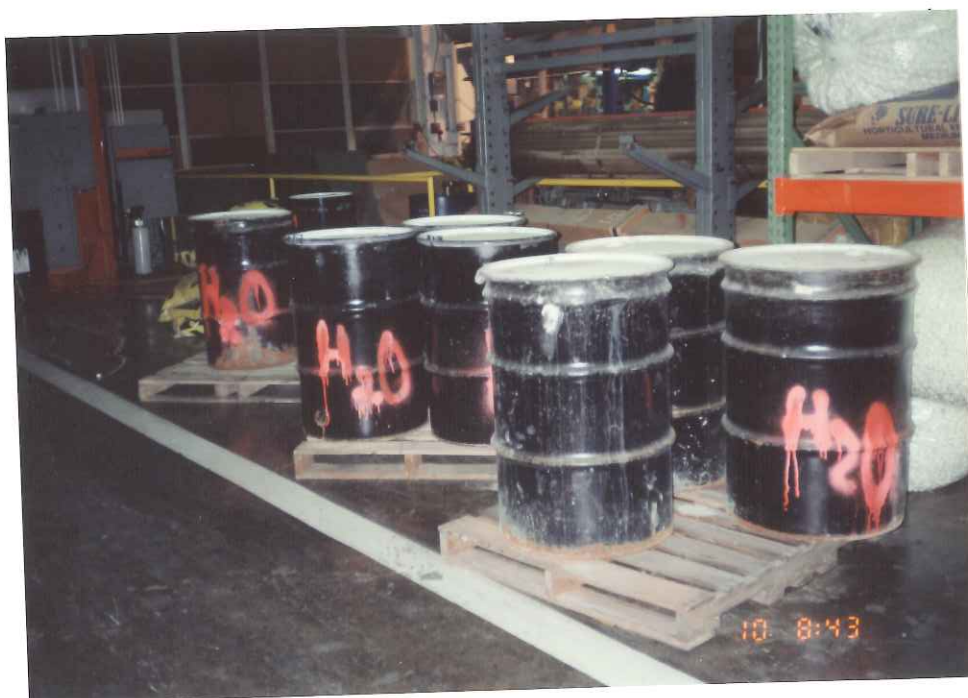
Photograph No. 10

Unit Description: At the time of the VSI, the Wash Water Storage Area was located across the aisle from the Indoor Hazardous Waste Storage Area (SWMU 3). The unit was storing wash water generated from floor cleaning associated with the closure of the Hazardous Waste Storage Shed (SWMU 1). Seven, 55-gallon drums were observed on wooden pallets. The unit measured the area of three wood pallets, about 15 square feet. The pallets were stored on a concrete floor. PRC did not observe any floor drains in the area. PRC did observe a crack in the floor (see Photograph No. 10).

The unit contained seven, 55-gallon drums of wash water. The drums were stored closed and were labeled "H<sub>2</sub>O". Rust was evident on some of the drums. No evidence of release was noted.

Recommendations: None.

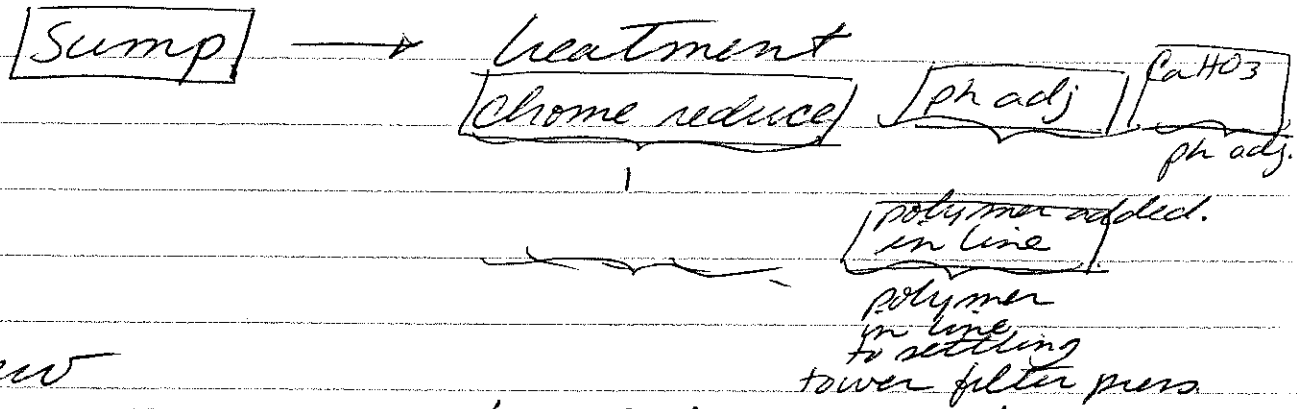
Old one & new one similar Sump for R&D & cust. service old.

new  
[sump] → hold tanks → treatment

[chrome reduce.] [ph adj.] [ph adj.]

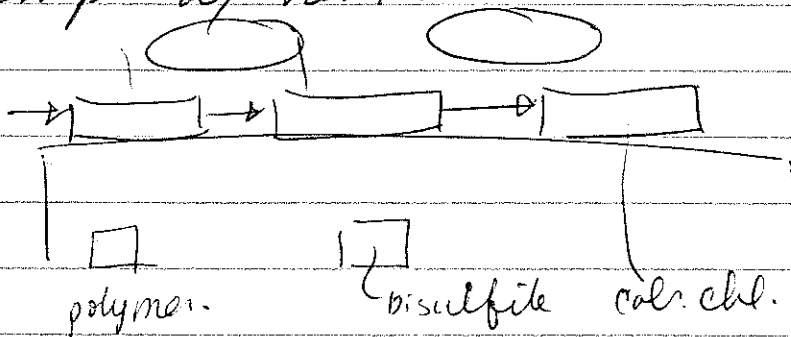
15,000 gal. holding tanks.

control system

tanks & equip in good condition
